**Flood Control Project Maintenance
Levee Inspections**

Maintenance Issue Types Only, Levee Inspection Report By Mile - Spring 2017

Reclamation District No. 2063 Crows Landing

Waterway	Bank	Unit Miles	Inspection Start/End	Inspector
Unit No. 01 San Joaquin River	Right	10.44	04/11/2017 04/11/2017	Richard Willoughby

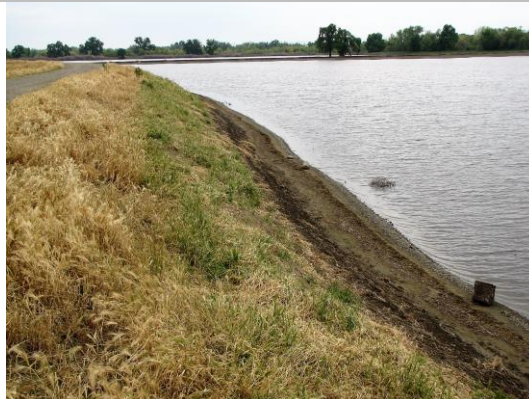
Photo 2 of 2 : SP_2017_RD2063_112_59_20170411_00122.jpg

LM Start	1.83	Rating **	M	Issue No.	59 (cont)	
LM End	1.93	Issue Type +	Ma	Location *	WS	
Category	Earthen Levee			GPS Latitude/Longitude		
				Start		End
Item	Erosion / Bank Caving			37.457653 °	37.456258 °	
				-121.033728 °	-121.033645 °	
DWR ID	DWR_RD2063_01_s_2017_59					
Comment Code						
E1 : Note and monitor erosion site.						
Inspector Comment						
Minor erosion at waterward toe.

Looking upstream at minor erosion on waterward slope.

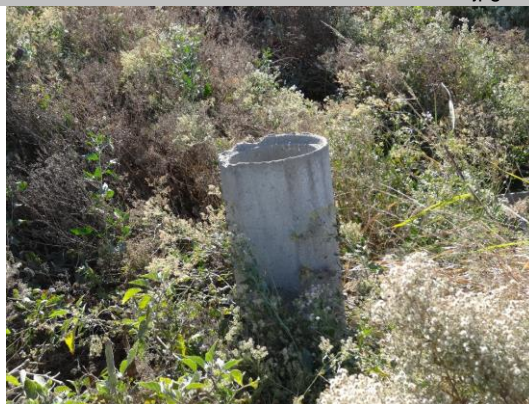
Photo 1 of 3 : UCIP_SP_2017_51823_43348.jpg

LM Start	2.27	Rating **	A/W	Issue No.	65
LM End	2.27	Issue Type +	Ma	Location *	LS
Category	Supplemental			GPS Latitude/Longitude	
				Start	End
Item	DWR UCIP LMA Responsibility			37.451946 °	37.451946 °
				-121.030672 °	-121.030672 °
DWR ID					
Comment Code					
Inspector Comment					
FS_ID:51823					
DS_ID:22081					
EP_NO: N/A					
Repair Type: No Action Needed					
Crossing Status: Found					
UCIP Comments: - concrete standpipe on waterside toe.- concrete distribution box on landside.- an alfalfa valve on waterside toe.					
FIELD_STRUCT_DESC: 30-inch CM pipe through the levee 12.0 feet below the crown. Flap gate on waterward end. Slide gate in distribution box on landward end. Concrete "U" headwall on the waterward end.					
O&M Manual SJR 006, Sept. 1961.					
FS Date: 11/5/2013

WS view: concrete standpipe on levee toe.

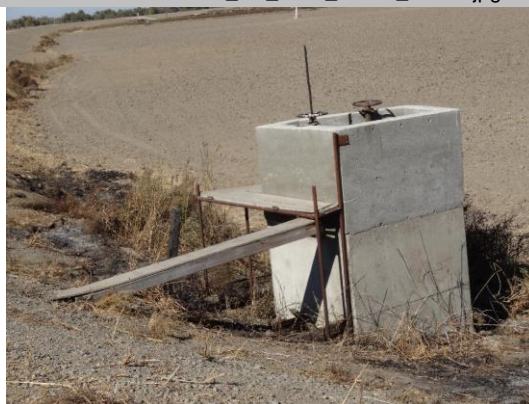
Photo 2 of 3 : UCIP_SP_2017_51823_43347.jpg

LS view: concrete distribution box and temporary walkway on levee toe.

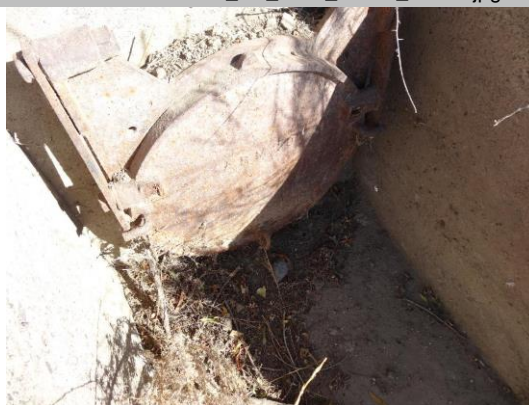
Photo 2 of 3 : UCIP_SP_2017_24435_43483.jpg

WS view: U shaped headwall outlet structure and pipe with flap gate.

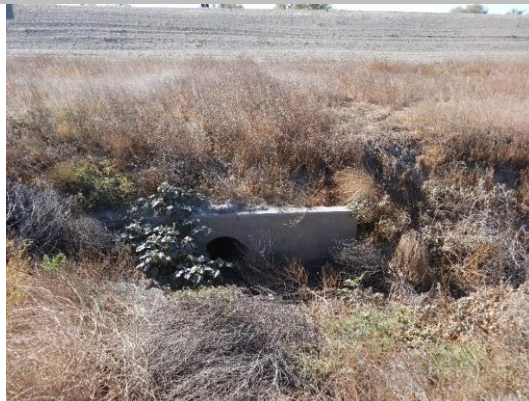
Photo 3 of 3 : UCIP_SP_2017_24435_43482.jpg

LM Start	2.62	Rating **	M	Issue No.	68 (cont)	
LM End	2.62	Issue Type +	Ma	Location *	LS	
Category	Supplemental			GPS Latitude/Longitude		
				Start	End	
Item	DWR UCIP LMA Responsibility			37.448233 °	37.448233 °	
				-121.026521 °	-121.026521 °	
DWR ID						
Comment Code						
Inspector Comment						
FS_ID:24435						
DS_ID:22086						
EP_NO: N/A						
Repair Type: Non-Urgent						
Crossing Status: Found						
UCIP Comments: Both pipe ends 70 ft off the levee center.Clearing and cleaning of inlet/outlet pipe needed.						
FIELD_STRUCT_DESC: 24-inch CM pipe through the levee 12.0 feet below the crown. Flap gate on the waterward end. Concrete headwall on both ends. Installed by USCE 1961. O&M Manual SJR 006, Sept. 1961.						
FS Date: 11/5/2013

LS view: concrete headwall with CMP 70 ft off the levee center.

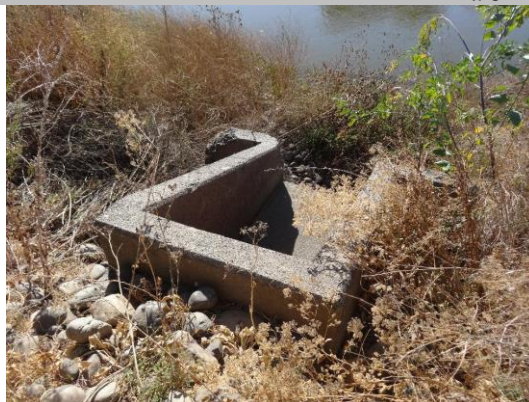
Photo 1 of 3 : UCIP_SP_2017_25023_45102.jpg

LM Start	2.68	Rating **	A/W	Issue No.	69
LM End	2.68	Issue Type +	Ma	Location *	LS
Category	Supplemental			GPS Latitude/Longitude	
				Start	End
Item	DWR UCIP LMA Responsibility			37.447475 °	37.447475 °
				-121.026017 °	-121.026017 °
DWR ID					
Comment Code					
Inspector Comment					
FS_ID:25023 DS_ID:22087 EP_NO: N/A Repair Type: No Action Needed Crossing Status: Found UCIP Comments: Both pipe ends about 85 feet off the levee center. FIELD_STRUCT_DESC: 24-inch CM pipe through the levee 20.3 feet below the crown. Flap gate on the waterward end. Concrete headwall on both ends. Installed by USCE 1961. O&M Manual SJR 006, Sept. 1961. FS Date: 11/5/2013

WS view: U typed concrete headwall on river bank.

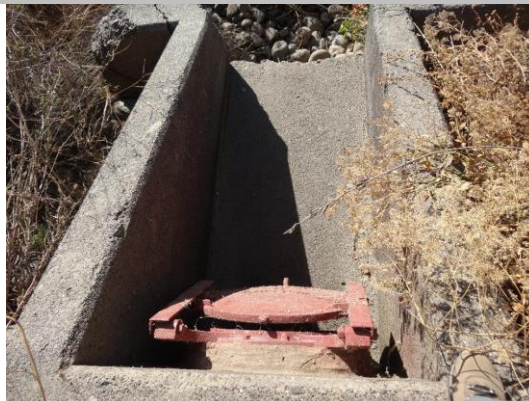
Photo 2 of 3 : UCIP_SP_2017_25023_45101.jpg

WS view: pipe, flap gate, and concrete headwall on river bank.

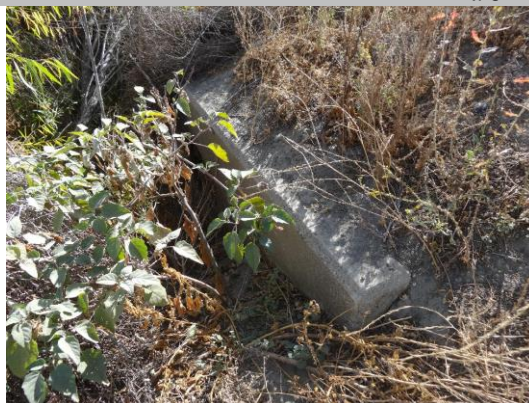
Photo 3 of 3 : UCIP_SP_2017_25023_45100.jpg

LS view: pipe and concrete headwall off the levee toe.

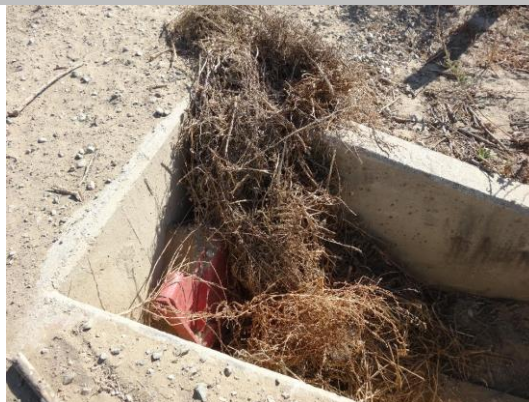
Photo 1 of 3 : UCIP_SP_2017_24443_43522.jpg

LM Start	2.93	Rating **	M	Issue No.	70
LM End	2.93	Issue Type +	Ma	Location *	LS
Category	Supplemental			GPS Latitude/Longitude	
				Start	End
Item	DWR UCIP LMA Responsibility			37.443871 °	37.443871 °
				-121.025775 °	-121.025775 °
DWR ID					
Comment Code					
Inspector Comment					
FS_ID:24443 DS_ID:22088 EP_NO: N/A Repair Type: Non-Urgent Crossing Status: Found UCIP Comments: - clear and clean debris FIELD_STRUCT_DESC: Abandoned 24-inch CM pipe through the levee 9.5 feet below the crown. Flap gate on the waterward end. Pipe open on landward end. Concrete headwall on both ends. O&M Manual SJR 006, Sept. 1961 FS Date: 11/5/2013

WS view: U typed concrete headwall on levee slope.

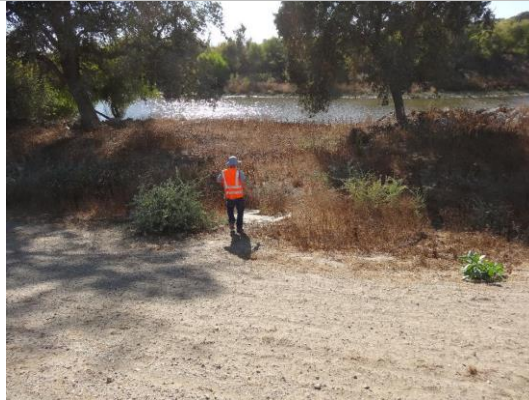
Photo 1 of 3 : UCIP_SP_2017_24469_43645.jpg

LM Start	3.29	Rating **	M	Issue No.	71
LM End	3.29	Issue Type +	Ma	Location *	LS
Category	Supplemental			GPS Latitude/Longitude	
				Start	End
Item	DWR UCIP LMA Responsibility			37.441213 °	37.441213 °
				-121.021130 °	-121.021130 °
DWR ID					
Comment Code					
Inspector Comment					
FS_ID:24469					
DS_ID:22089					
EP_NO: N/A					
Repair Type: Non-Urgent					
Crossing Status: Found					
UCIP Comments: - cleaning required in inlet pipe.- new flap gate					
FIELD_STRUCT_DESC: 24-inch CM pipe through the levee 12.5 feet					
below the crown. Flap gate on the waterward end. Concrete headwall					
on both ends. O&M Manual SJR 006, Sept. 1961.					
FS Date: 11/5/2013

WS view: U typed concrete headwall on levee toe

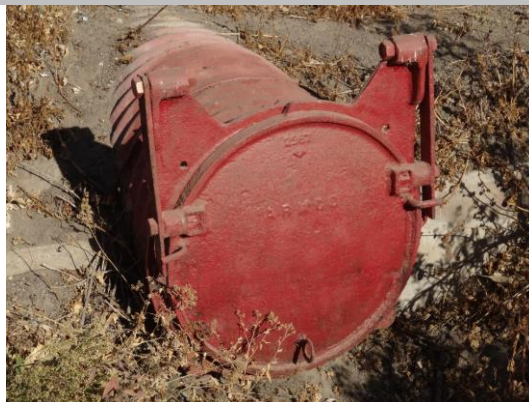
Photo 1 of 3 : UCIP_SP_2017_24485_43667.jpg

LM Start	3.64	Rating **	M	Issue No.	72
LM End	3.64	Issue Type +	Ma	Location *	LS
Category	Supplemental			GPS Latitude/Longitude	
				Start	End
Item	DWR UCIP LMA Responsibility			37.436845 °	37.436845 °
				-121.017826 °	-121.017826 °
DWR ID					
Comment Code					
Inspector Comment					
FS_ID:24485 DS_ID:22093 EP_NO: N/A Repair Type: Non-Urgent Crossing Status: Found UCIP Comments: - new flap gate on waterside.- cleaning and clearing of inlet box needed. FIELD_STRUCT_DESC: 24-inch CM pipe through the levee 12.0 feet below the crown. Flap gate and concrete saddle on the waterward end. Concrete drop inlet box on landward side. Installed by USCE 1961. O&M Manual SJR 006, Sept. 1961. FS Date: 11/5/2013

WS view: pipe, flap gate, and concrete saddle on levee slope

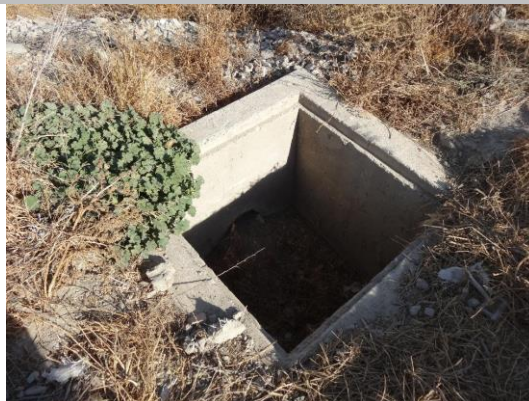
Photo 2 of 3 : UCIP_SP_2017_24485_43666.jpg

LM Start	3.64	Rating **	M	Issue No.	72 (cont)	
LM End	3.64	Issue Type +	Ma	Location *	LS	
Category	Supplemental			GPS Latitude/Longitude		
				Start	End	
Item	DWR UCIP LMA Responsibility			37.436845 °	37.436845 °	
				-121.017826 °	-121.017826 °	
DWR ID						
Comment Code						
Inspector Comment						
FS_ID:24485						
DS_ID:22093						
EP_NO: N/A						
Repair Type: Non-Urgent						
Crossing Status: Found						
UCIP Comments: - new flap gate on waterside.- cleaning and clearing of inlet box needed.						
FIELD_STRUCT_DESC: 24-inch CM pipe through the levee 12.0 feet below the crown. Flap gate and concrete saddle on the waterward end. Concrete drop inlet box on landward side. Installed by USCE 1961.						
O&M Manual SJR 006, Sept. 1961.						
FS Date: 11/5/2013

LS view: concrete drop inlet box on levee toe.

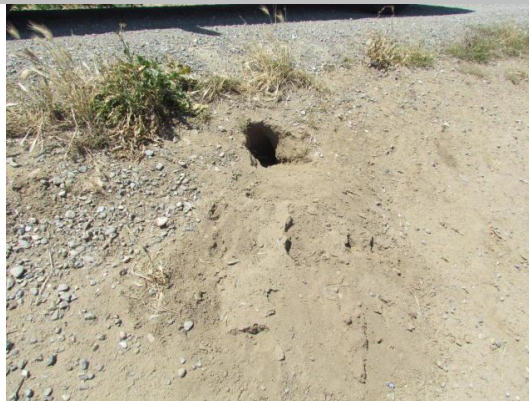
Photo 1 of 2 : SP_2017_RD2063_112_29_20170411_00009.jpg

LM Start	3.68	Rating **	M	Issue No.	29
LM End	3.76	Issue Type +	Ma	Location *	LS
Category	Earthen Levee			GPS Latitude/Longitude	
				Start	End
Item	Animal Control			37.436421 °	37.435767 °
				-121.017321 °	-121.016119 °
DWR ID	DWR_RD2063_01_s_2012_29				
Comment Code					
A3 : No rodents visible, but rodent burrows visible; need to backfill and compact or grout burrows.					
Inspector Comment					
Several rodent holes on landward shoulder and slope.

Looking east at typical rodent hole on landward shoulder.

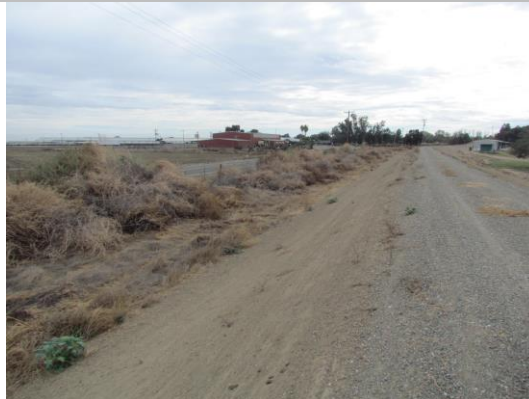
Photo 2 of 2 : SP_2017_RD2063_112_2_20170411_00002.jpg

LM Start	3.89	Rating **	M	Issue No.	2 (cont)	
LM End	3.97	Issue Type +	Ma	Location *	LS	
Category	Earthen Levee			GPS Latitude/Longitude		
				Start		End
Item	Vegetation			37.434506 °		37.433441 °
				-121.014394 °		-121.013633 °
DWR ID	DWR_RD2063_01_s_2016_2					
Comment Code						
V2 : Remove the wild growth other than native grasses from the levee slopes.						
Inspector Comment						
Remove dense veg on landward berm.

Looking south at dense veg at landward toe and berm.

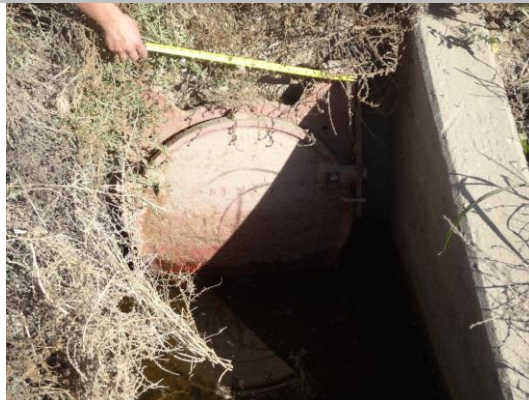
Photo 1 of 3 : UCIP_SP_2017_51821_43842.jpg

Comment Code					
Inspector Comment					
FS_ID:51821 DS_ID:22096 EP_NO: N/A Repair Type: No Action Needed Crossing Status: Found UCIP Comments: 05/11/2017 Review of photos indicate less than 1/4 of the inlet is silted in. Since the pipe is in good condition, it has been downgraded from Non-Urgent to No Action Needed. (K. Fazel - UCIP)11/05/2013:- new flap gate on waterside.- cleaning of outlet and inlet pipes required. (P. Amatya - DWR) FIELD_STRUCT_DESC: 24-inch CM pipe through the levee 12.0 feet below the crown. Flap gate on the waterwad end. Concrete headwall on both ends. Installed by USCE 1961. O&M Manual SJR 006, Sept. 1961 FS Date: 11/5/2013

WS view: pipe, flap gate, and concrete headwall on drainage ditch.

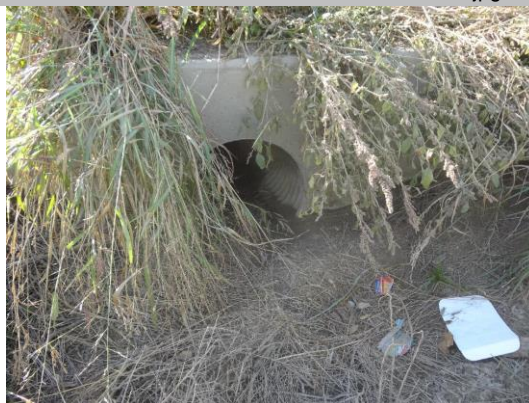
Photo 2 of 3 : UCIP_SP_2017_51821_43841.jpg

LS view: CM pipe and concrete headwall on levee toe.

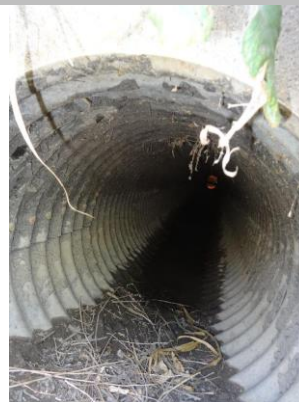
Photo 3 of 3 : UCIP_SP_2017_51821_43840.jpg

LS view: inside view of the CM pipe on levee toe.

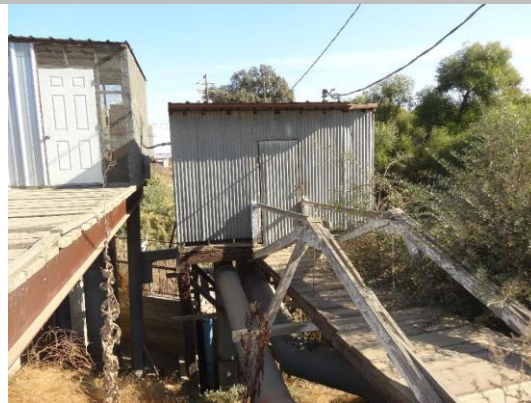
Photo 1 of 3 : UCIP_SP_2017_24603_43860.jpg

LM Start	4.17	Rating **	A/W	Issue No.	76
LM End	4.17	Issue Type +	Ma	Location *	LS
Category	Supplemental			GPS Latitude/Longitude	
				Start	End
Item	DWR UCIP LMA Responsibility			37.431005 °	37.431005 °
				-121.011843 °	-121.011843 °
DWR ID					
Comment Code					
Inspector Comment					
FS_ID:24603					
DS_ID:22100					
EP_NO: 6721					
Repair Type: No Action Needed					
Crossing Status: Found					
UCIP Comments: - Overhead power line.- looks new inlet pipes in pumphouse.					
FIELD_STRUCT_DESC: 1 of 3: A 18-inch and 20 steel pipes through the levee 2.0 feet below the crown. Pumphouse and timber walkway on the landward side. 16-inch steel pipe through the levee 3.6 feet below the crown. (App. No. 6721 and A). O&M Manual SJR 006, Sept. 1961.					
FS Date: 11/6/2013

LS view: walkway to pump, pump house (right), and pipes on levee

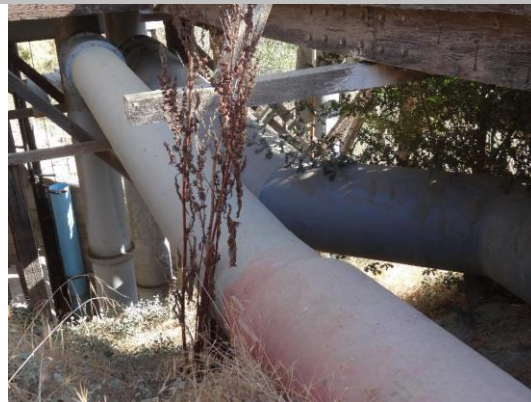
Photo 2 of 3 : UCIP_SP_2017_24603_43862.jpg

LS view: pipes (18" pipe - left, 20" pipe- right) under walkway and pump house on levee slope.

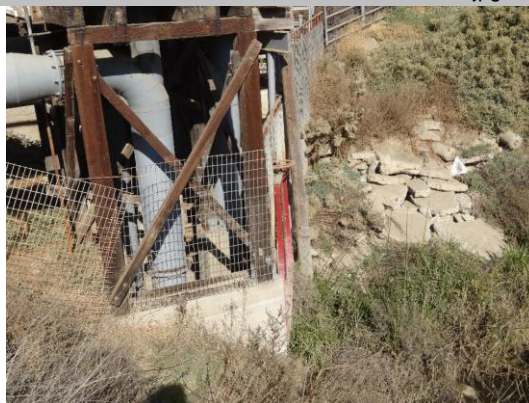
Photo 3 of 3 : UCIP_SP_2017_24603_43861.jpg

LM Start	4.17	Rating **	A/W	Issue No.	76 (cont)	
LM End	4.17	Issue Type +	Ma	Location *	LS	
Category	Supplemental			GPS Latitude/Longitude		
				Start	End	
Item	DWR UCIP LMA Responsibility			37.431005 °	37.431005 °	
				-121.011843 °	-121.011843 °	
DWR ID						
Comment Code						
Inspector Comment						
FS_ID:24603						
DS_ID:22100						
EP_NO: 6721						
Repair Type: No Action Needed						
Crossing Status: Found						
UCIP Comments: - Overhead power line.- looks new inlet pipes in pumphouse.						
FIELD_STRUCT_DESC: 1 of 3: A 18-inch and 20 steel pipes through the levee 2.0 feet below the crown. Pumphouse and timber walkway on the landward side. 16-inch steel pipe through the levee 3.6 feet below the crown. (App. No. 6721 and A). O&M Manual SJR 006, Sept. 1961.						
FS Date: 11/6/2013

LS view: intake sump under pump house, and pipes in drainage ditch.

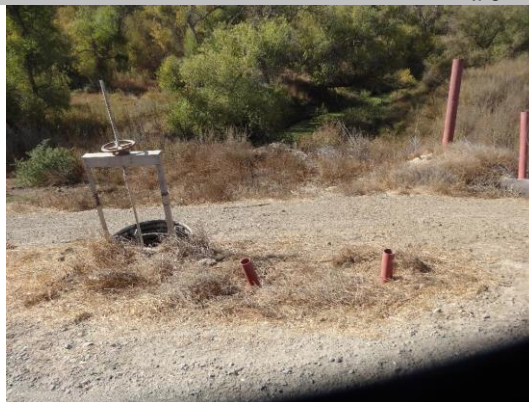
Photo 1 of 3 : UCIP_SP_2017_25026_45115.jpg

LM Start	4.17	Rating **	A/W	Issue No.	77
LM End	4.17	Issue Type +	Ma	Location *	LS
Category	Supplemental			GPS Latitude/Longitude	
				Start	End
Item	DWR UCIP LMA Responsibility			37.431003 °	37.431003 °
				-121.011834 °	-121.011834 °
DWR ID					
Comment Code					
Inspector Comment					
FS_ID:25026 DS_ID:22120 EP_NO: 6721 Repair Type: No Action Needed Crossing Status: Found UCIP Comments: New intake pipe to pump.Pump house on concrete sump in drainage ditch. FIELD_STRUCT_DESC: 2 of 3: A 20-inch and 18-inch steel pipes through the levee 2.0 feet below the crown. Pumphouse and timber walkway on the landward side. 16-inch steel pipe through the levee 3.6 feet below the crown. (App. No. 6721 and A). O&M Manual SJR 006, Sept. 1961. FS Date: 11/6/2013

WS view: air vents (red) on levee slope.

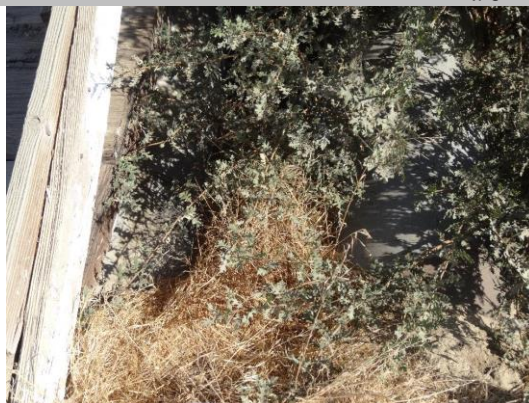
Photo 2 of 3 : UCIP_SP_2017_25027_45119.jpg

LS view: walkway to pump and pipe (right) on levee slope.

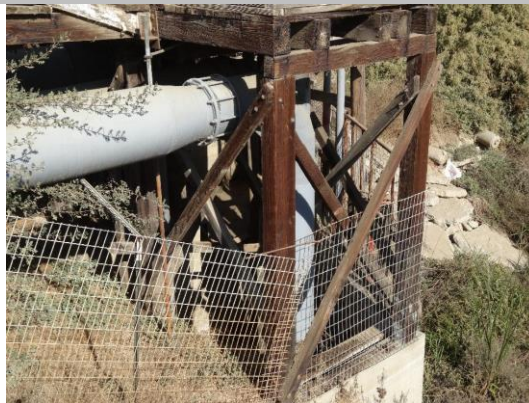
Photo 3 of 3 : UCIP_SP_2017_25027_45118.jpg

LM Start	4.18	Rating **	A/W	Issue No.	78 (cont)
LM End	4.18	Issue Type +	Ma	Location *	LS
Category	Supplemental			GPS Latitude/Longitude	
				Start	End
Item	DWR UCIP LMA Responsibility			37.430990 °	37.430990 °
				-121.011814 °	-121.011814 °
DWR ID					
Comment Code					
Inspector Comment					
FS_ID:25027 DS_ID:22121 EP_NO: 6721 Repair Type: No Action Needed Crossing Status: Found UCIP Comments: - new intake pipe to the pump.- overhead power line. FIELD_STRUCT_DESC: 3 of 3: 16-inch steel pipe through the levee 3.6 feet below the crown. Pumphouse and timber walkway on the landward side. A 18-inch and 20 steel pipes through the levee 2.0 feet below the crown. (App. No. 6721 and A). O&M Manual SJR 006, Sept. 1961. FS Date: 11/6/2013

LS view: intake pipes and pump house on concrete sump in drainage ditch.

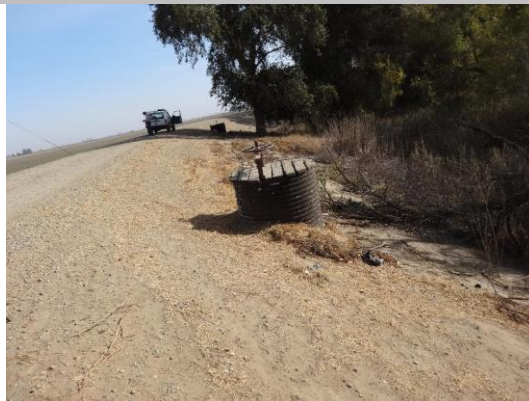
Photo 1 of 3 : UCIP_SP_2017_24632_43953.jpg

FS_ID:24632
DS_ID:22110
EP_NO: N/A
Repair Type: No Action Needed
Crossing Status: Found
UCIP Comments: No pipe visible on landside. Flap gate not found on the waterside end. Concrete "U" headwalls not found on ends of pipe.
FIELD_STRUCT_DESC: 36-inch CM pipe through the levee 25.5 feet below the crown. Slide gate in CM pipe riser on the waterward slope.
Installed by USCE 1961. O&M Manual SJR 006, Sept. 1961.
FS Date: 11/6/2013

WS view: CMP riser on levee slope. No pipe visible on levee slope.

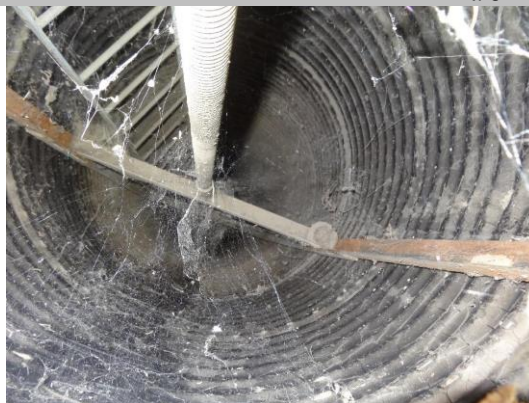
Photo 2 of 3 : UCIP_SP_2017_24632_43952.jpg

WS view: slide gate in CMP riser on levee slope.

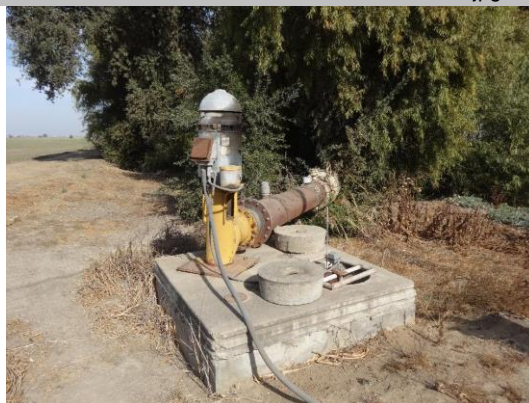
Photo 3 of 3 : UCIP_SP_2017_24632_43951.jpg

LM Start	7.48	Rating **	A/W	Issue No.	84 (cont)
LM End	7.48	Issue Type +	Ma	Location *	WS
Category	Supplemental			GPS Latitude/Longitude	
				Start	End
Item	DWR UCIP LMA Responsibility			37.404195 °	37.404195 °
				-120.986709 °	-120.986709 °
DWR ID					
Comment Code					
Inspector Comment					
FS_ID:24632					
DS_ID:22110					
EP_NO: N/A					
Repair Type: No Action Needed					
Crossing Status: Found					
UCIP Comments: No pipe visible on landside.Flap gate not found on the waterside end. Concrete "U" headwalls not found on ends of pipe.					
FIELD_STRUCT_DESC: 36-inch CM pipe through the levee 25.5 feet below the crown. Slide gate in CM pipe riser on the waterward slope.					
Installed by USCE 1961. O&M Manual SJR 006, Sept. 1961.					
FS Date: 11/6/2013

LS view: concrete distribution box on levee toe. Pump on the box discharges water into irrigation ditch.

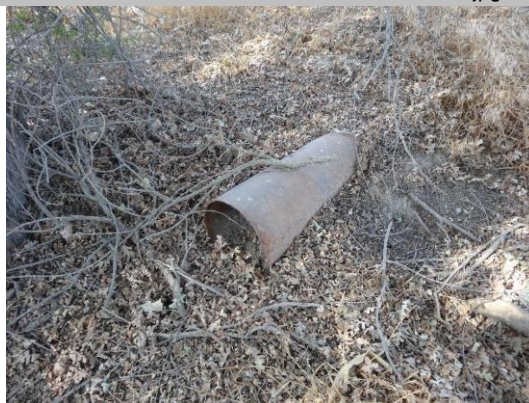
Photo 2 of 3 : UCIP_SP_2017_25031_45140.jpg

LM Start	7.50	Rating **	M	Issue No.	85 (cont)	
LM End	7.50	Issue Type +	Ma	Location *	WS	
Category	Supplemental			GPS Latitude/Longitude		
				Start		End
Item	DWR UCIP LMA Responsibility			37.404130 °		37.404130 °
				-120.986454 °		-120.986454 °
DWR ID						
Comment Code						
Inspector Comment						
FS_ID:25031 DS_ID:22111 EP_NO: N/A Repair Type: Non-Urgent Crossing Status: Found UCIP Comments: Pump mounted on top of concrete pipe sump not found on the waterside. Concrete standpipe not found on the landward side.Looks abandoned. FIELD_STRUCT_DESC: Abandoned 12-inch steel pipe encased in concrete 7.0 feet below the crown. Slide gate in CM pipe riser on the waterward slope. Steel pipe opens on both sides of the levee. Installed by USCE1961. O&M Manual SJR 006, Sept. 1961. FS Date: 11/6/2013

WS view: steel pipe with open-end on waterside slope.

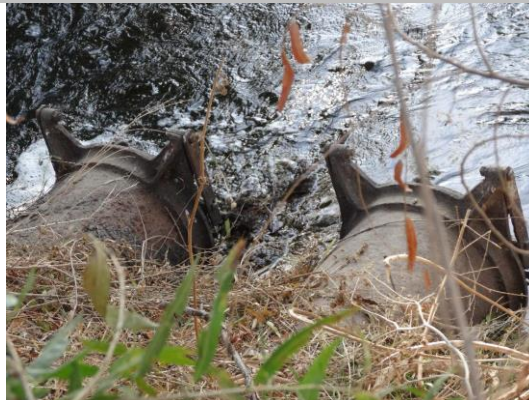
Photo 2 of 3 : UCIP_SP_2017_24651_44004.jpg

WS view: two flap gates on outfall pipe ends.

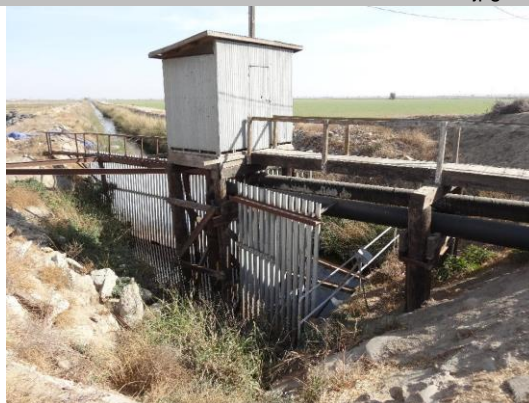
Photo 3 of 3 : UCIP_SP_2017_24651_44003.jpg

LM Start	8.46	Rating **	M	Issue No.	86 (cont)
LM End	8.46	Issue Type +	Ma	Location *	LS
Category	Supplemental			GPS Latitude/Longitude	
				Start	End
Item	DWR UCIP LMA Responsibility			37.397883 °	37.397883 °
				-120.972342 °	-120.972342 °
DWR ID					
Comment Code					
Inspector Comment					
FS_ID:24651 DS_ID:22124 EP_NO: N/A Repair Type: Non-Urgent Crossing Status: Found UCIP Comments: - working during field inspection.- blocked siphon breaker. FIELD_STRUCT_DESC: 1 of 2: Two 16-inch steel pipes through the levee 3.5 feet below the crown. Siphon breakers in CM pipe risers on the waterward slope. Flap gate on the waterward end of each pipe. Two pumps on timber pile structure on the landward side. Timber walkway from levee to pump structure. O&M Manual SJR 006, Sept. 1961. FS Date: 11/6/2013

LS view: pipes under walkway to pump house.

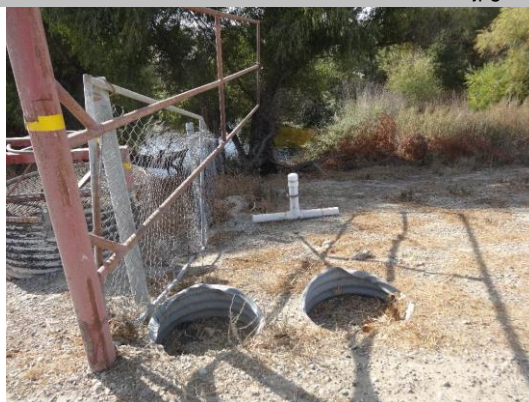
Photo 1 of 3 : UCIP_SP_2017_24652_44008.jpg

LM Start	8.46	Rating **	M	Issue No.	87
LM End	8.46	Issue Type +	Ma	Location *	LS
Category	Supplemental			GPS Latitude/Longitude	
				Start	End
Item	DWR UCIP LMA Responsibility			37.397872 °	37.397872 °
				-120.972336 °	-120.972336 °
DWR ID					
Comment Code					
Inspector Comment					
FS_ID:24652 DS_ID:22112 EP_NO: N/A Repair Type: Non-Urgent Crossing Status: Found UCIP Comments: - working during field inspection.- blocked siphon breaker. FIELD_STRUCT_DESC: 2 of 2: Two 16-inch steel pipes through the levee 3.5 feet below the crown. Siphon breakers in CM pipe risers on the waterward slope. Flap gate on the waterward end of each pipe. Two pumps on timber pile structure on the landward side. Timber walkway from levee to pump structure. O&M Manual SJR 006, Sept. 1961. FS Date: 11/6/2013

WS view: two siphon breakers in CMP risers on levee slope.

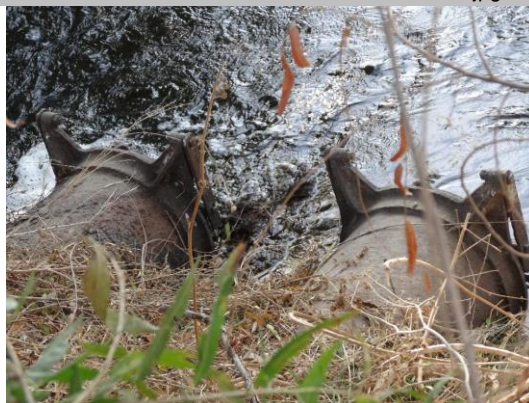
Photo 2 of 3 : UCIP_SP_2017_24652_44007.jpg

LM Start	8.46	Rating **	M	Issue No.	87 (cont)
LM End	8.46	Issue Type +	Ma	Location *	LS
Category	Supplemental			GPS Latitude/Longitude	
				Start	End
Item	DWR UCIP LMA Responsibility			37.397872 °	37.397872 °
				-120.972336 °	-120.972336 °
DWR ID					
Comment Code					
Inspector Comment					
FS_ID:24652 DS_ID:22112 EP_NO: N/A Repair Type: Non-Urgent Crossing Status: Found UCIP Comments: - working during field inspection.- blocked siphon breaker. FIELD_STRUCT_DESC: 2 of 2: Two 16-inch steel pipes through the levee 3.5 feet below the crown. Siphon breakers in CM pipe risers on the waterward slope. Flap gate on the waterward end of each pipe. Two pumps on timber pile structure on the landward side. Timber walkway from levee to pump structure. O&M Manual SJR 006, Sept. 1961. FS Date: 11/6/2013

WS view: two flap gates on outfall pipe ends.

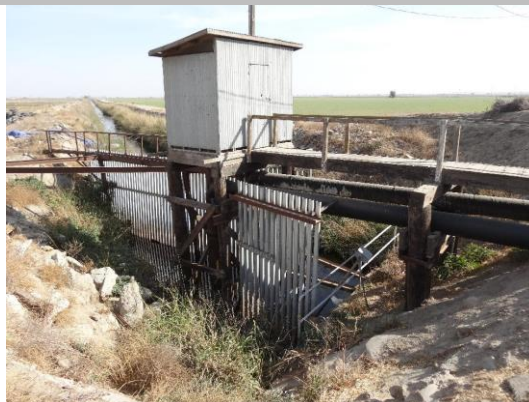
Photo 3 of 3 : UCIP_SP_2017_24652_44006.jpg

LS view: pipes under walkway to pump house.

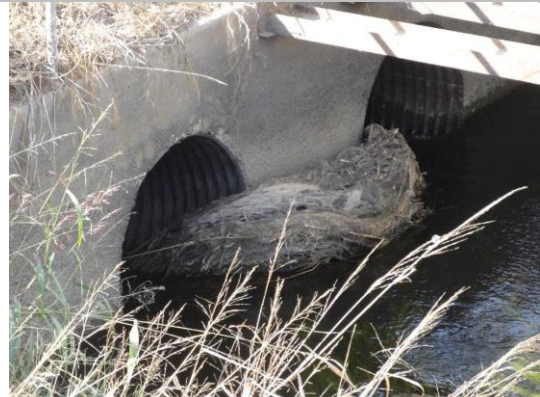
Photo 3 of 3 : UCIP_SP_2017_24650_44000.jpg

LM Start	8.46	Rating **	A/W	Issue No.	88 (cont)	
LM End	8.46	Issue Type +	Ma	Location *	LS	
Category	Supplemental			GPS Latitude/Longitude		
				Start	End	
Item	DWR UCIP LMA Responsibility			37.397865 °	37.397865 °	
				-120.972332 °	-120.972332 °	
DWR ID						
Comment Code						
Inspector Comment						
FS_ID:24650 DS_ID:22113 EP_NO: N/A Repair Type: No Action Needed Crossing Status: Found UCIP Comments: Working during field inspection. FIELD_STRUCT_DESC: 1 of 2: Two 42-inch CM pipes through levee 18.0 feet below the crown. Slide gates in CM pipe risers on the waterward slope. Flap gates, concrete saddle and apron on the waterside ends of pipes.Concrete headwall on landward end. Reclamation District No. 2063 Pumping Plant. O&M Manual SJR 006, Sept. 1961. FS Date: 11/6/2013

LS view: drainage pipes under walkway in drainage ditch.

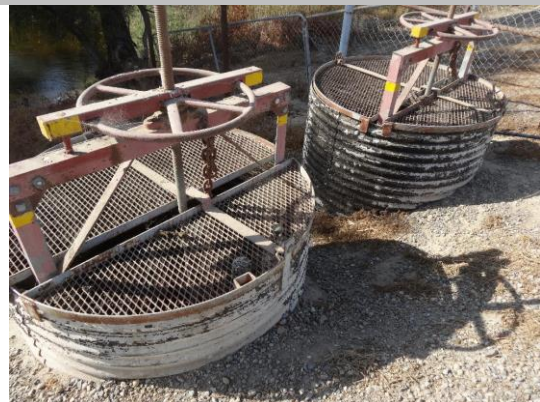
Photo 1 of 3 : UCIP_SP_2017_24636_43965.jpg

LM Start	8.46	Rating **	A/W	Issue No.	89
LM End	8.46	Issue Type +	Ma	Location *	LS
Category	Supplemental			GPS Latitude/Longitude	
				Start	End
Item	DWR UCIP LMA Responsibility			37.397850 °	37.397850 °
				-120.972322 °	-120.972322 °
DWR ID					
Comment Code					
Inspector Comment					
FS_ID:24636 DS_ID:22125 EP_NO: N/A Repair Type: No Action Needed Crossing Status: Found UCIP Comments: - working during field inspection. FIELD_STRUCT_DESC: 2 of 2: Two 42-inch CM pipes through levee 18.0 feet below the crown. Slide gates in CM pipe risers on the waterward slope. Flap gates, concrete saddle and apron on the waterward ends of pipes. Concrete headwall on landward end. Reclamation District No. 2063 Pumping Plant. O&M Manual SJR 006, Sept. 1961. FS Date: 11/6/2013

WS view: two slide gates in CMP risers on levee slope

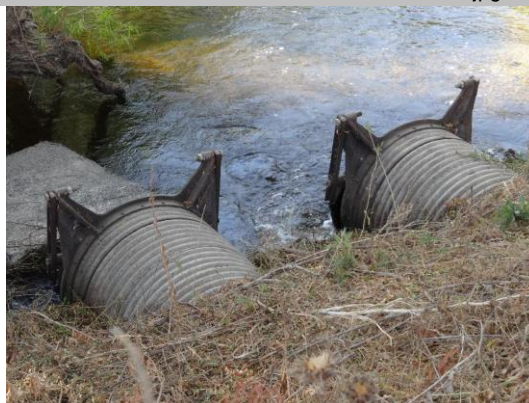
Photo 2 of 3 : UCIP_SP_2017_24636_43964.jpg

LM Start	8.46	Rating **	A/W	Issue No.	89 (cont)
LM End	8.46	Issue Type +	Ma	Location *	LS
Category	Supplemental			GPS Latitude/Longitude	
				Start	End
Item	DWR UCIP LMA Responsibility			37.397850 °	37.397850 °
				-120.972322 °	-120.972322 °
DWR ID					
Comment Code					
Inspector Comment					
FS_ID:24636					
DS_ID:22125					
EP_NO: N/A					
Repair Type: No Action Needed					
Crossing Status: Found					
UCIP Comments: - working during field inspection.					
FIELD_STRUCT_DESC: 2 of 2: Two 42-inch CM pipes through levee					
18.0 feet below the crown. Slide gates in CM pipe risers on the					
waterward slope. Flap gates, concrete saddle and apron on the					
waterward ends of pipes. Concrete headwall on landward end.					
Reclamation District No. 2063 Pumping Plant. O&M Manual SJR 006,					
Sept. 1961.					
FS Date: 11/6/2013

WS view: two flap gates on outfall pipe ends.

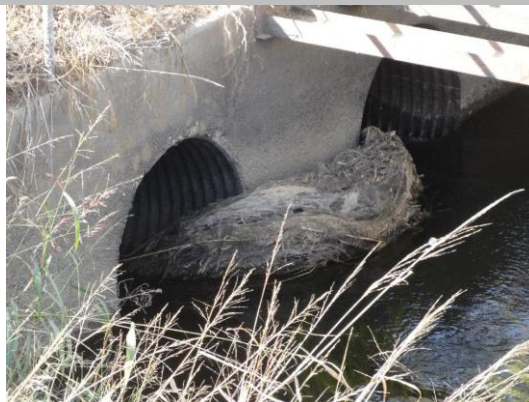
Photo 3 of 3 : UCIP_SP_2017_24636_43963.jpg

LS view: drainage pipes under walkway in drainage ditch.

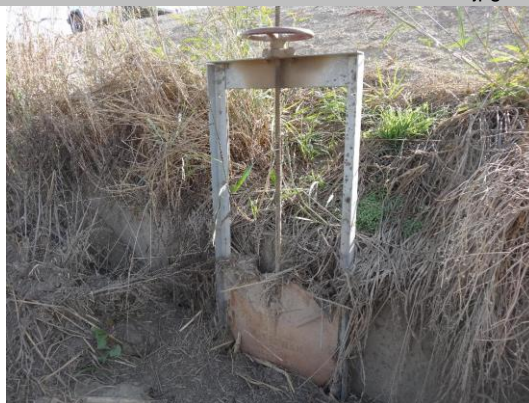
Photo 1 of 2 : UCIP_SP_2017_24638_43967.jpg

FS_ID:24638
DS_ID:22114
EP_NO: N/A
Repair Type: No Action Needed
Crossing Status: Found
UCIP Comments: Flap gate and concrete "U" headwall not visible due to dense vegetation on waterside.
FIELD_STRUCT_DESC: 24-inch CM pipe through levee 12.0 feet below crown. Flap gate and concrete "U" headwall on waterward end. Grouted spillway 7 feet in length on waterward end. Slide gate on pipe end and concrete headwall on landside end. Installed by USCE 1961. O&M Manual SJR 006, Sept. 1961.
FS Date: 11/6/2013

WS view: concrete headwall on levee end. Slide gate on pipe end.

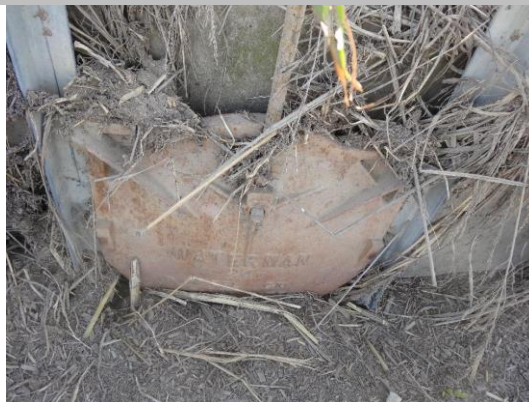
Photo 2 of 2 : UCIP_SP_2017_24638_43966.jpg

WS view: close view of slide gate on pipe end.

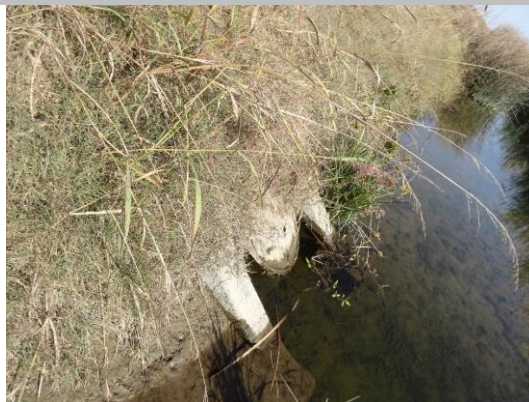
Photo 2 of 3 : UCIP_SP_2017_51825_43983.jpg

LM Start	9.50	Rating **	A/W	Issue No.	91
LM End	9.50	Issue Type +	Ma	Location *	LS
Category	Supplemental			GPS Latitude/Longitude	
				Start	End
Item	DWR UCIP LMA Responsibility			37.390682 °	37.390682 °
				-120.958287 °	-120.958287 °
DWR ID					
Comment Code					
Inspector Comment					
FS_ID:51825 DS_ID:22115 EP_NO: N/A Repair Type: No Action Needed Crossing Status: Found UCIP Comments: 04/11/2017 LS inlet has been cleared, as per DWR inspector Richard Willoughby. (K. Fazel - UCIP)11/06/2013 Landside inlet blocked by plywood. (P. Amatya - DWR) FIELD_STRUCT_DESC: 24-inch CM pipe through the levee 5.6 feet below the crown. Flap gate and concrete "U" headwall on the waterward end. Concrete headwall on the landward end. Installed by USCE 1961. O&M Manual SJR 006, Sept. 1961. FS Date: 4/11/2017

WS view: U type headwall and flap gate visible on the bank of the water channel.

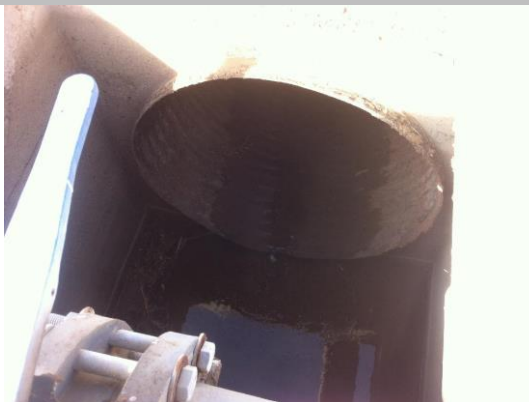
Photo 1 of 3 : UCIP_SP_2017_24644_43986.jpg

LM Start	9.94	Rating **	A/W	Issue No.	92
LM End	9.94	Issue Type +	Ma	Location *	LS
Category	Supplemental			GPS Latitude/Longitude	
				Start	End
Item	DWR UCIP LMA Responsibility			37.390563 °	37.390563 °
				-120.950329 °	-120.950329 °
DWR ID					
Comment Code					
Inspector Comment					
FS_ID:24644 DS_ID:22116 EP_NO: N/A Repair Type: No Action Needed Crossing Status: Found UCIP Comments: - not very old structure. FIELD_STRUCT_DESC: 48-inch CM pipe through the levee and across drain ditch on the waterward side 6.0 feet below the crown. Slide gate and concrete box on the waterside end. Concrete box on the landward end. Installed by USCE 1961. O&M Manual SJR 006, Sept. 1961. FS Date: 11/6/2013

WS view: CM pipe on outlet concrete box.

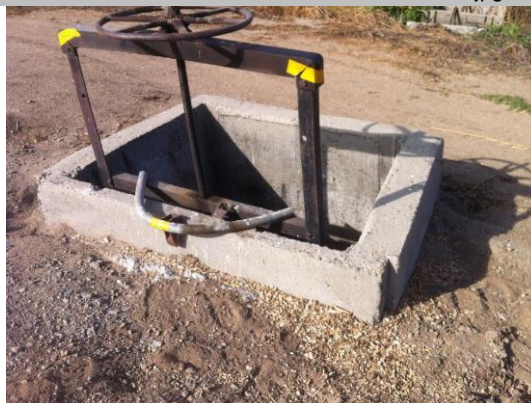
Photo 2 of 3 : UCIP_SP_2017_24644_43985.jpg

LM Start	9.94	Rating **	A/W	Issue No.	92 (cont)	
LM End	9.94	Issue Type +	Ma	Location *	LS	
Category	Supplemental			GPS Latitude/Longitude		
				Start	End	
Item	DWR UCIP LMA Responsibility			37.390563 °	37.390563 °	
				-120.950329 °	-120.950329 °	
DWR ID						
Comment Code						
Inspector Comment						
FS_ID:24644 DS_ID:22116 EP_NO: N/A Repair Type: No Action Needed Crossing Status: Found UCIP Comments: - not very old structure. FIELD_STRUCT_DESC: 48-inch CM pipe through the levee and across drain ditch on the waterward side 6.0 feet below the crown. Slide gate and concrete box on the waterside end. Concrete box on the landward end. Installed by USCE 1961. O&M Manual SJR 006, Sept. 1961. FS Date: 11/6/2013

LS view: CM pipe with slide gate on inlet concrete box.

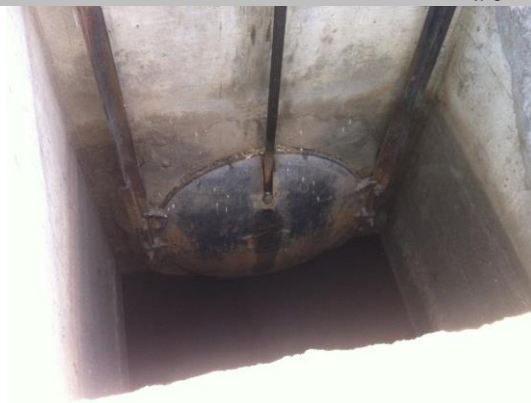
Photo 3 of 3 : UCIP_SP_2017_24644_43984.jpg

LM Start	9.94	Rating **	A/W	Issue No.	92 (cont)
LM End	9.94	Issue Type +	Ma	Location *	LS

LS view: inside view of slide gate in concrete box.

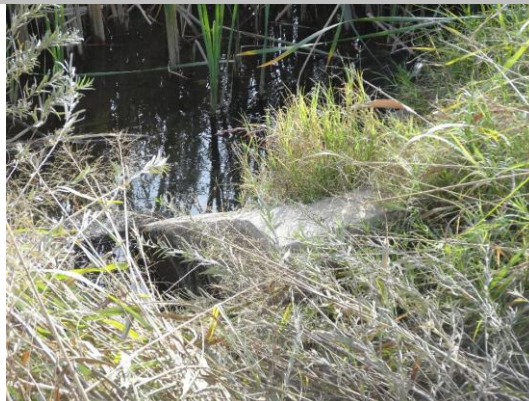
Photo 1 of 2 : UCIP_SP_2017_24645_43988.jpg

LM Start	9.95	Rating **	M	Issue No.	93
LM End	9.95	Issue Type +	Ma	Location *	LS
Category	Supplemental			GPS Latitude/Longitude	
				Start	End
Item	DWR UCIP LMA Responsibility			37.390572 °	37.390572 °
				-120.950156 °	-120.950156 °
DWR ID					
Comment Code					
Inspector Comment					
FS_ID:24645 DS_ID:22117 EP_NO: N/A Repair Type: Non-Urgent Crossing Status: Found UCIP Comments: - waterside not accessible.- partially blocked inlet opening on landside. FIELD_STRUCT_DESC: 24-inch CM pipe through the levee 4.6 feet below the crown. Flap gate and concrete "U" headwall on the waterward end. Concrete headwall on landward end. Installed by USCE 1961. O&M Manual SJR 006, Sept. 1961. FS Date: 11/6/2013

WS view: concrete U type headwall on channel bank. Not accessible.
